FEAP TR 96/20 October 1996

Demonstration of Lead-Based Paint Removal and Chemical Stabilization Using Blastox[®]

by
Vincent F. Hock, Curt M. Gustafson, Donald M. Cropek and Susan A. Drozdz,
U.S. Army Construction Engineering Research Laboratories
Champaign, IL 61826-9005

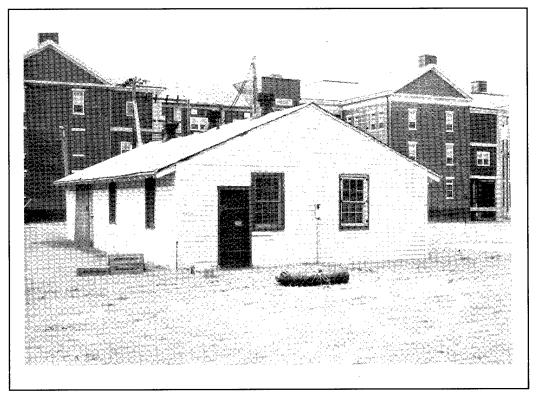
Figure 12 shows the lead-painted building (T4561) at Fort Meade before the abatement procedure.* Before removing the LBP, XRF analysis was done on each side of the building (Figure 13). Table 5 lists a lead content of 0.0 to 10+ mg/cm², indicating significant amounts of lead present in the paint on each side of the building. A 50 sq ft test sample was then abrasively blasted (without Blastox®) to determine the amount of leachable lead in the waste sample without the additive. The data in Table 5 list a range of 7.3 to 14 ppm of leached lead in samples with no Blastox®.

Figure 12. North and east walls of Building T4561 before demonstration at Fort Meade.

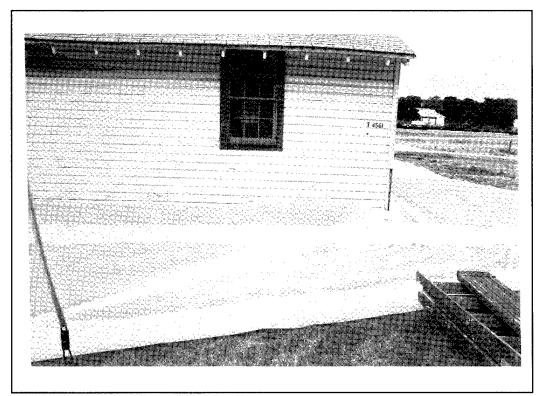
The building containment, as shown in Figures 14 and 15, protected the environment from lead contamination. Blastox® was then blended on site (30 weight percent)* with coal slag prior to abrasive blasting the rest of the LBP remaining on the building.

Figure 14. Polyethylene tarps create a continuous ground cover to protect soil at Fort Meade.

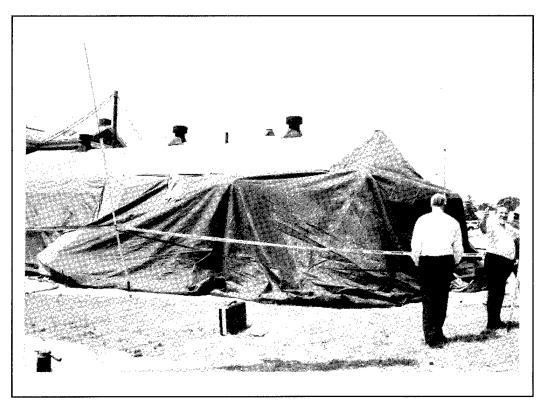
Figure 15. Completed enclosure for waste containment at Fort Meade.

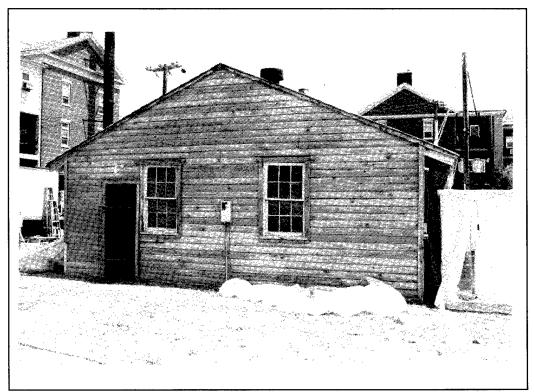
The XRF data in Table 5 show less than 0.8 (± 0.5) mg/cm² of lead remaining on the building exterior. This translates to a lead hazard-free building exterior as defined by the Maryland USEPA (Figure 16). The TCLP results from the waste product consisting of spent abrasive, LBP, and Blastox® (Table 5) show that, in all cases, lead leached below the USEPA limit of 5 ppm. The TCLP data from both USACERL and Fort Meade are 0.10 to 4.7 ppm leachable lead—less than regulatory threshold of 5 ppm leachable lead.

Figure 16. The end result: a lead-hazard free building at Fort Meade.

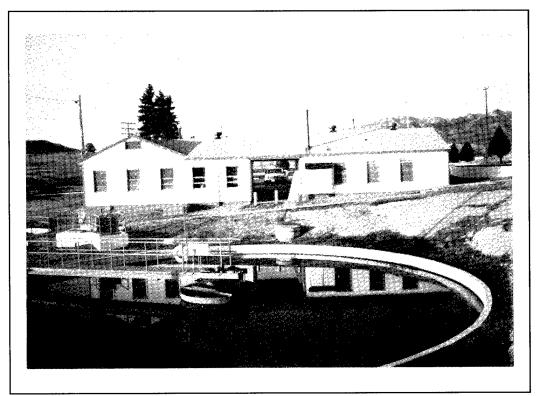
Figure 17 shows the lead-painted building (sewage treatment plant) at Fort Carson before the abatement procedure.* The Fort Carson results closely resemble Fort Meade's, except for the air monitoring. In this demonstration, a 100 percent containment system was used instead of the 85 percent system used at Fort Meade (Figure 18), so that the amount of lead detected by area monitors outside containment was much less at Fort Carson (Table 9). The more stringent containment was used at the request of the installation. The TCLP results were all below 3.19 ppm lead (Tables 10 and 11). (Figure 19 shows the Fort Carson sewage treatment plant following abatement.) The cost was slightly higher than the Fort Meade, from \$2.50 to \$2.74 per sq ft (Table 12) due to the more stringent containment.

Figure 17. East side of Sewage Treatment Building at Fort Carson.

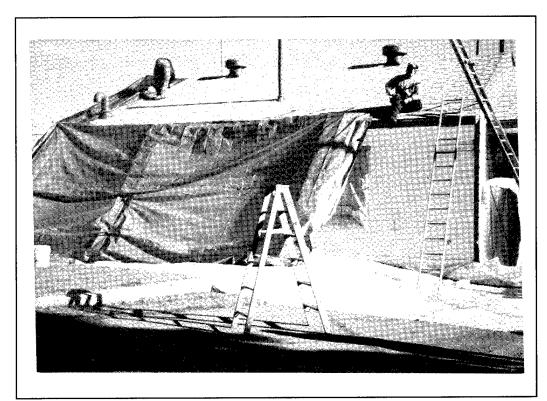
Figure 18. Containment of the Fort Carson site.

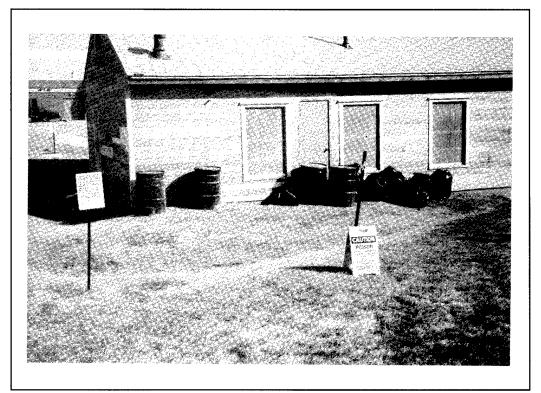
Figure 19. Sewage Treatment Plant at Fort Carson following abatement, showing nonhazardous waste placed in proper containers.

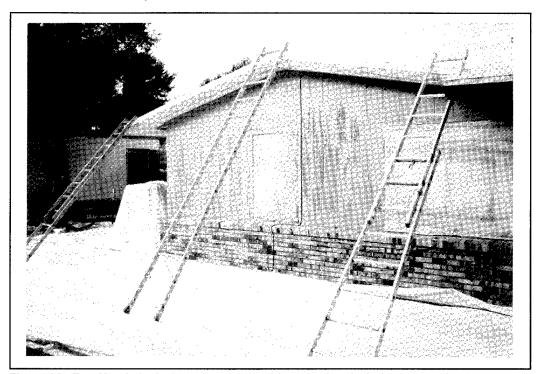
Figure 20. Fort Hood site before abatement, with ground and window covers in place.

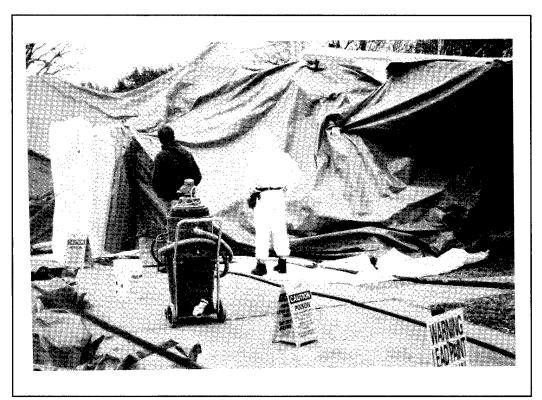
Figure 20 shows the Fort Hood FHU before abatement with the ground and window covers in place. The field test results are very similar to those of Fort Carson because they were performed with the same specifications, including the 100 percent containment (Figure 21). As a result, the air-monitoring results were very low (Table 13) and the TCLP results were all less than 1 ppm (Tables 14 and 15). The cost for this abatement was comparable to that of Fort Carson, from \$2.74 to \$2.77 per sq ft (Table 16).

Figure 21. Containment erected and lead paint abatement in progress at Fort Hood.

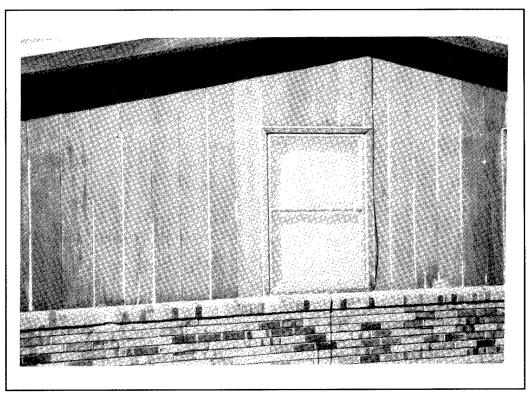
There was lead dust present before abatement; however, the amount significantly increased during the removal process. With simple cleaning after abatement, the amount of lead present was near the amount present before abatement, and when Mr. CleanTM was used, the lead levels were actually lower than present before abatement. Figure 22 shows the exterior wood surface after abatement.

Figure 22. Fort Hood site with abatement completed and wood prepared for repainting.

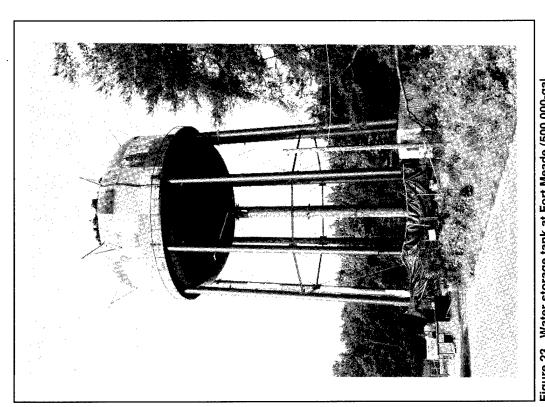
In the summer of 1994, the Directorate of Public Works at Fort Meade contracted to abate the LBP from the exterior surfaces of a 500,000-gal elevated water storage $tank^*$ (Figure 23). The paint was found to have 33 percent lead by weight. It was decided to use an engineered abrasive to remove the paint to generate a nonhazard-ous waste. It was necessary to use a 100 percent containment during abrasive blasting operations to prevent lead dust contamination of the surrounding site. The containment structure can be raised and lowered from ground level (Figure 24). Air monitoring of both the site and personnel was required, as was TCLP analysis of the chemically stabilized waste. The air-monitoring data (Table 18) show that lead levels outside the containment area did not exceed 30 μ g/m³ as established by 29 CFR 1910.1025. Figure 25 shows sections of the water tank after abrasive blasting and Figure 26 shows work in progress on the water tank supports.

Figure 23. Water storage tank at Fort Meade (500,000-gal capacity).

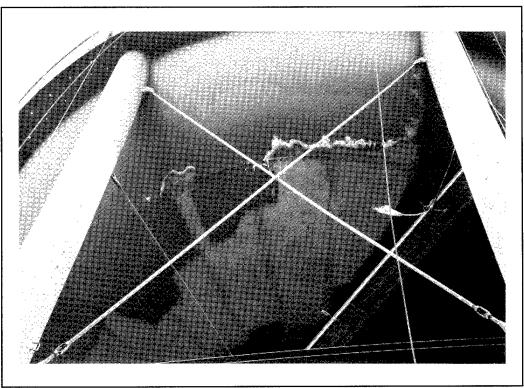
Figure 25. A section of the Fort Meade water tank that has been abrasive blasted.

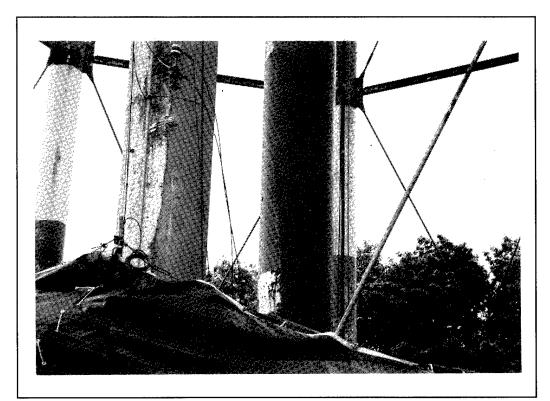
Figure 26. Work in progress on the water tank supports.
